RE: Plano Well 5 – Repairs and Reinstallation

JOB NAME	Plano, IL Well No. 5	Pump #5	DATE	10/14/2021
JOB NO.	1132835	INSPECTED BY	Jason Gray	
Layne s/n	661-C-0286	BOWL ASSEMBLY	12GM – 4 stage, 8.31" trim. S/N 1308XCT77106	
		COLUMN ASSEMBLY	(8" x 5") x 1-7/16" x 2-1/2" oil lube	
		DISCHARGE HEAD	Byron Jackson	
		MOTOR	75HP U.S. VHS 1780RPM 3ph 460V motor

DOWNHOLE VIDEO SURVEY REPORT

Client: City of Plano, IL Date: 10/07/2021
 Project Number: 1132835 Well No: 5 S.W.L. 22'
 Location: Klatt Field, 751 E. Main St, Plano, IL 60545 (Left field)

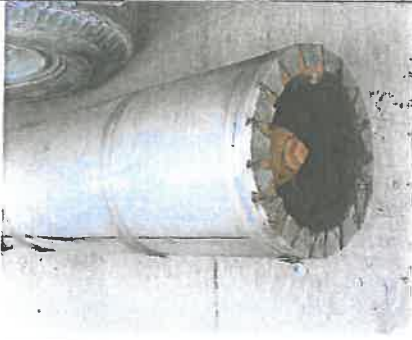
SST bowl shroud
Good condition

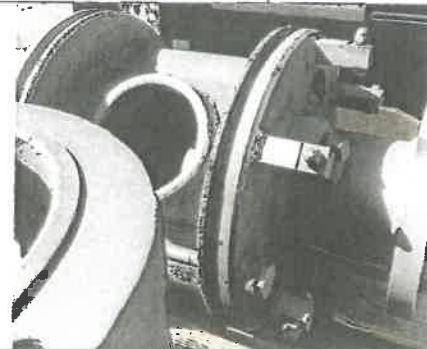
Pitless Adapter
General corrosion

1. Surface plate in good condition. Recommend prime and paint exterior.
2. Pitless in fair condition. Minor pitting in o-ring groove. Recommend steel epoxy hole, prime and paint interior/exterior.

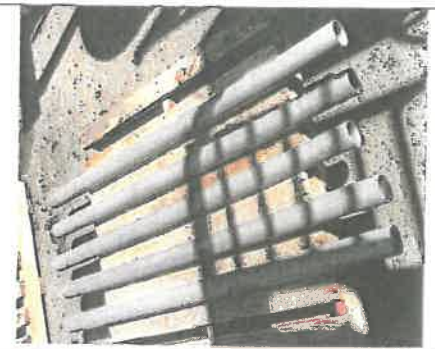
Oil Tubing
Excessive wear and pitting

8. 2-1/2" – 8THD oil tubing – Upper one ok for reuse. Remainder have pitting in ID/OD. Replace all but top piece.
9. Bowl assembly – All impellers showing signs of heavy de-zincification. Replace all impellers. Volutes show minimal wear. Bushings in cases (0.013" to 0.018" clearances) need to be replaced. Deep pitting in suction case. Fill with steel epoxy. Impeller shaft 1-11/16" x 69-1/4" with 1-7/16" – 8THD turndown is pitted and needs replacing. Hardware and collets ok for reuse.

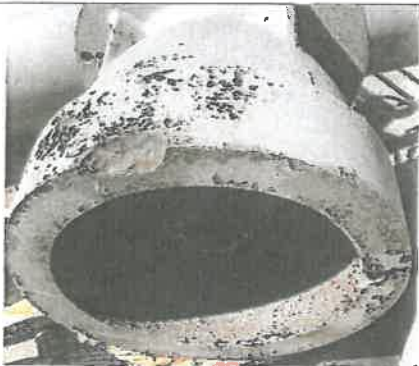
Volute
Minimal wear and pitting

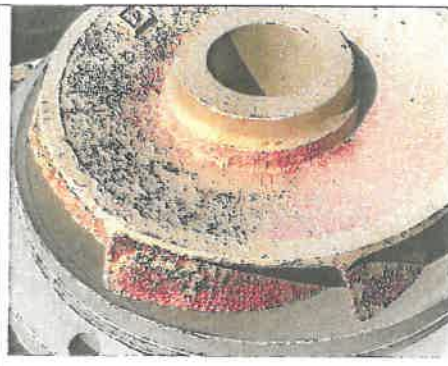
Impeller
signs of dezincification

Briefly, the pump repairs are rather routine, except for the recommendation to replace the Byron Jackson bowl assembly. This bowl assembly was replaced almost 9 years ago, and is showing significant wear for the age. At this time, we are unsure of the cause. The bowl had some pitting on the exterior, and extensive pitting on the impellers. One housing also had a significant piece missing. Although the bowl assembly is repairable, the time and materials it would take to repair would be close to a new bowl assembly cost, and similar lead time. We are recommending that we reinstall the large S.S. sheet around the bowl.

Due to the extent of pitting in the shaft and bowl assemblies, we would recommend to replace the entire bowl assembly.

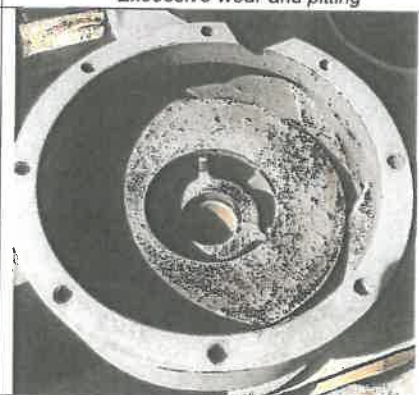
Volute
Minimal pitting

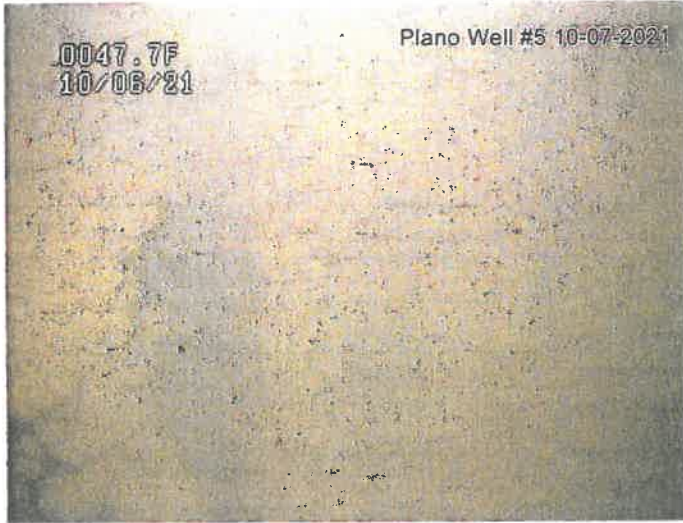
47'

Depth		Description
22'		Static Water Level (SWL) and pitless
22'	44'	No light coming through. Can not make out walls but did see some floating debris. Oily residue on lense
44'		Top of screen. Large buildup on upper screen
50'		Second section of screen. Some buildup along screen
56.5'		Total measured depth

Well 5 is currently in poor condition overall. At a minimum we would recommend to superchlorinate the well, brush the upper casing, and bail any fill. We would also recommend to Sonar-Jet the screen to remove the buildup along the water producing zones.

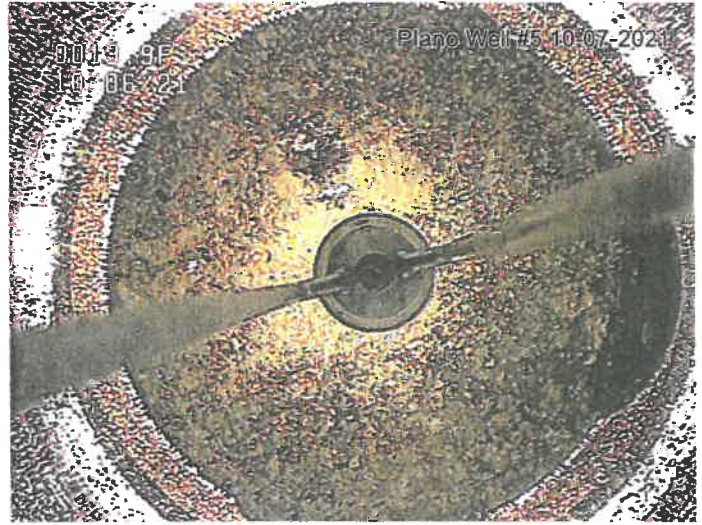
22' - SWL

The casing around the discharge appears to have some fairly large grooves. It is difficult to see the extent of the damage.
