RE: Plano Well 5 – Repairs and Reinstallation

JOB NAME	Plano, IL Well No. 5	Pump #5	DATE	10/14/2021
JOB NO.	1132835	INSPECTED BY	Jason Gray	
Layne s/n	661-C-0286	BOWL ASSEMBLY	12GM – 4 stage, 8.31" trim. S/N 1308XCT77106	
		COLUMN ASSEMBLY	(8" x 5") x 1-7/16" x 2-1/2" oil lube	
		DISCHARGE HEAD	Byron Jackson	
		MOTOR	75HP U.S. VHS 1780RPM 3ph 460V motor

DOWNHOLE VIDEO SURVEY REPORT

Client: City of Plano, IL Date: 10/07/2021
 Project Number: 1132835 Well No: 5 S.W.L. 22'
 Location: Klatt Field, 751 E. Main St, Plano, IL 60545 (Left field)

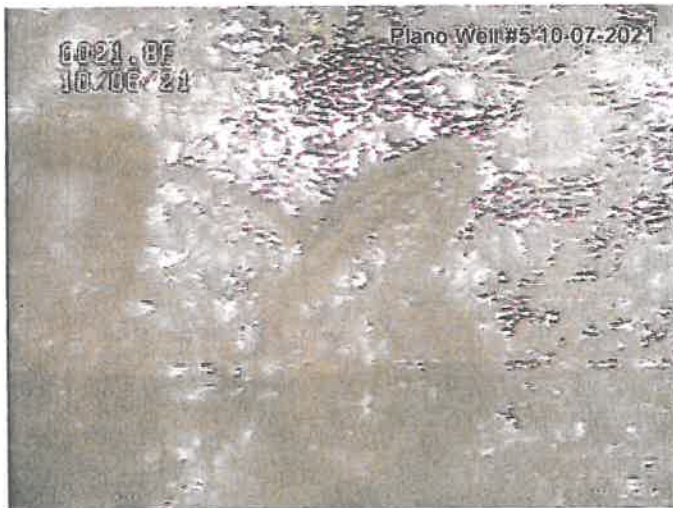
21'

The casing around the discharge appears to have some fairly large grooves. It is difficult to see the extent of the damage.
